# **Fire and Collapse, Faculty of Architecture Building, Delft University of Technology: Data Collection and Preliminary Analyses**

Brian Meacham<sup>1</sup> and Haejun Park, Worcester Polytechnic Institute, USA  
Michael Engelhardt and Adam Kirk, The University of Texas at Austin, USA  
Venkatesh Kodur, Michigan State University, USA  
IJsbrand van Straalen and Johan Maljaars, TNO, the Netherlands  
Kees van Weeren, Delft University of Technology, the Netherlands  
René de Feijter and Kees Both, Efectis, the Netherlands

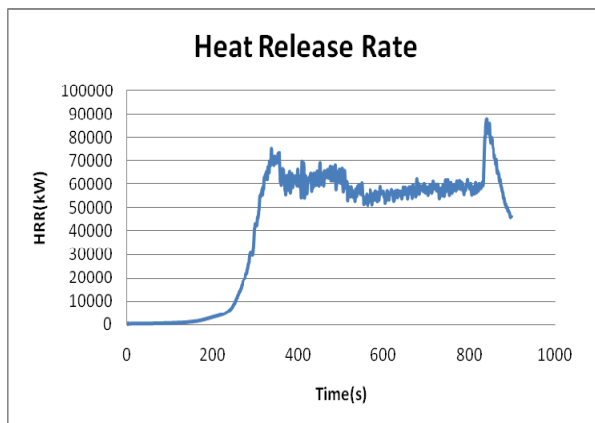
The HRR history of the simulation is shown in Fig. 9. Fig. 10 provides a snapshot of the FDS at 360 s into the simulation. Based on the level of data and information available, it is concluded that it possible to simulate the initial fire conditions with a reasonable degree of confidence.

Fig 9. HRR History for Initial Fire

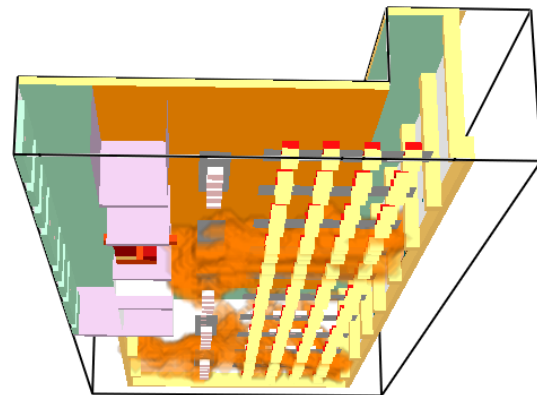
Fig 10. FDS Snapshot at 360 s

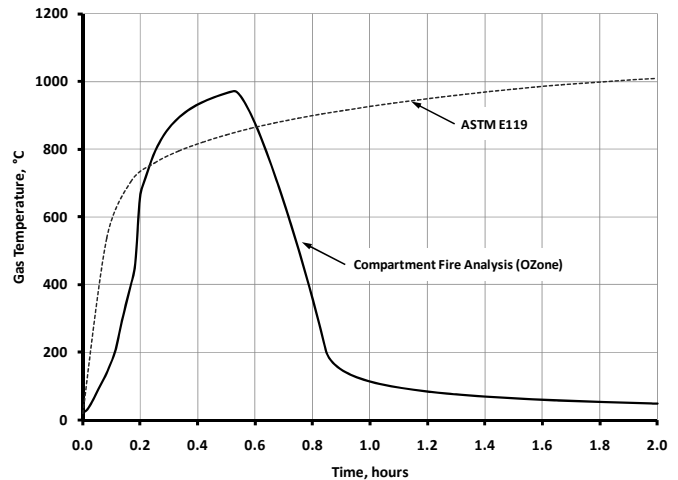
To estimate temperatures to which the structural members were exposed, simplified compartment fire analyses were conducted for a typical office in the northwest portion of the building. A single-zone approximation was used to characterize post-flashover conditions. A series of analyses were conducted using the computer programs OZone [18] and BRANZFIRE [19]. Published compartment time-temperature curves were also evaluated [20]. Parametric studies were conducted to consider a reasonable range of fire loads, ventilation conditions, and compartment boundary thermal properties. A typical result of such an analysis obtained from OZone is plotted in Fig. 13. Also shown for comparison is the ASTM E119 [21] time-temperature curve. Although the parametric study showed a range of time-temperature curves, the curve plotted in Fig. 13 was representative of the general trends of predicted peak temperatures and duration, and was used for subsequent heat transfer and structural analysis. The predicted peak temperature was on the order of  $950^{\circ}\text{C}$ , and the predicted duration of high temperatures, say greater than about  $300^{\circ}\text{C}$ , was on the order of 30 to 45 minutes. The time frame for which severe burning was observed in any given location on the northwest wing from photo and video evidence seems to suggest these predicted durations are reasonable.

Fig. 13. Typical Result of Compartment Fire Analysis

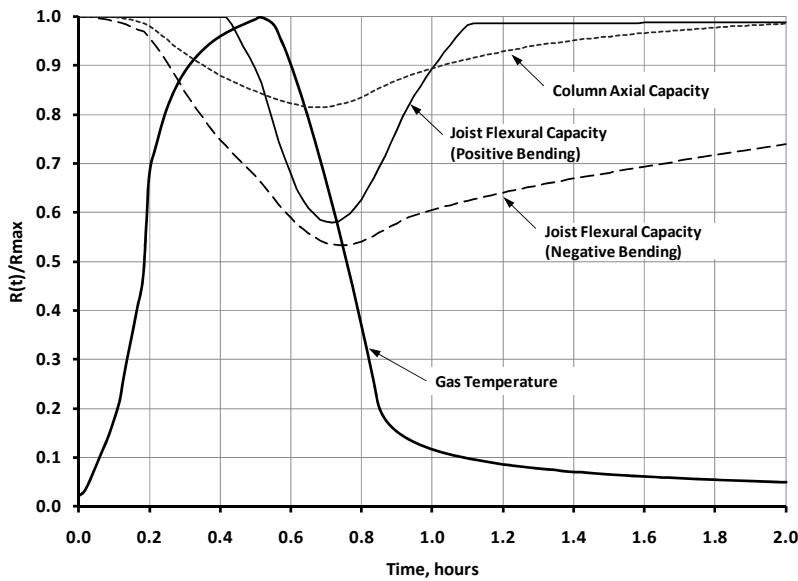
Representative results of member cross-section capacity analyses are shown in Fig. 14. This figure plots cross-section capacity as a function of time for three cases: joist flexural capacity for positive bending (tension on bottom), joist flexural capacity for negative bending, and column axial capacity. The gas temperature versus time curve that was used for this analysis is the OZone generated curve shown in Fig. 13. Note that the gas temperature-time curve is also plotted in Fig. 14. In Fig. 14, all quantities are normalized to their peak values. Gas temperatures are normalized to the peak gas temperature, which occurs approximately 30 minutes into the analysis. Member cross-section capacities are normalized to the capacities at  $20^{\circ}\text{C}$ . Thus, for example, a normalized capacity of 0.80 indicates that the cross-section retains 80-percent of its capacity at normal temperature.

Fig. 14. Normalized Cross-Section Capacities of Joist and Column

the members are at their weakest condition well into the cooling phase of the fire. This plot also shows that the most significant loss of capacity occurs for flexure in the joists. This significant loss of flexural capacity may be the result, in part, to the rather small concrete cover in these members. Note that the loss of axial capacity in the columns is rather small. The columns always retained more than 80-percent of their normal axial capacity throughout the analysis.

The member capacity plots in Fig. 14 show that as gas temperature increases, member capacity decreases. Similarly, as the gas temperature decreases, the members begin to regain capacity. The analysis predicts that the members reach their minimum capacity about 45 minutes into the analysis. At this point, the gas temperature is well past its peak (which occurs at 30 minutes) and has already cooled substantially. Thus,

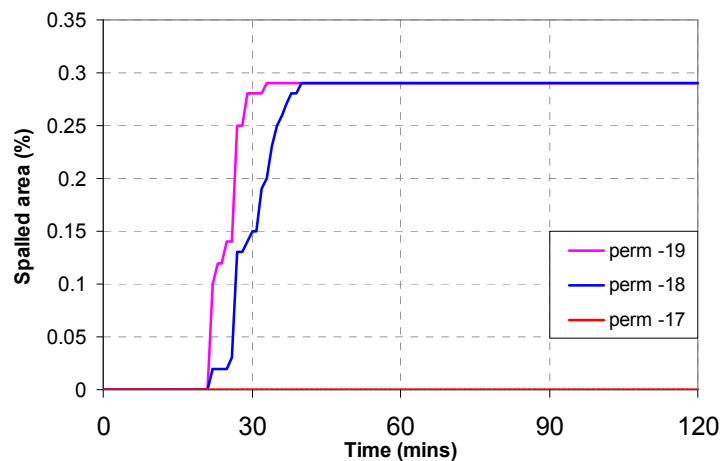
Results from the analysis indicate that when a permeability of  $10^{-17}$  is assumed, no spalling occurs and the RC column survives burn-out condition. When the permeability is changed to  $10^{-18}$  spalling is predicted to start in the 22<sup>nd</sup> minute of fire exposure and stops at about 40 minutes into the fire. At this time most of the cover concrete is lost, but the column in this case also did not fail. About 28.5% of the column cross-section was predicted to have spalled off. The survival of the column can be

Fig. 15 Progression of spalling

attributed to the fact that by the time the column lost enough mass due to spalling and lost strength due to degradation of material properties, the fire was in the decay phase and the column could regain its strength. This column could be said to have just marginally survived the fire. With a permeability of  $10^{-19}$  spalling starts a bit early at 21 minutes in the fire exposure and stops in 35 minutes. This column fails in 43 minutes into fire exposure. As stated, spalling progressed faster in this column and thus when the cover of concrete was lost the fire temperature were at its peak and thus the column could not sustain the applied load. Figure 15 shows the progression of spalling for the three permeability values. Figure 16 shows the area of cross-section lost in the column at 30 minutes (temperature peak) of exposure and 50 minutes (burnout) of exposure.

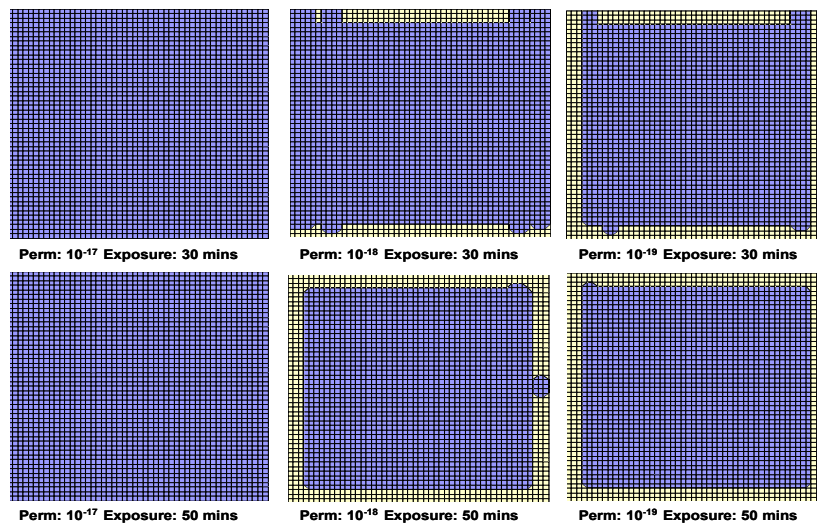
A review of post-fire photographs of the FOA building indicates loss of cross-sections in certain parts of the buildings. This was postulated to be due to fire induced spalling. As a preliminary analysis, the above MSU model was applied to analyze a typical reinforced concrete (RC) column from the TUD building to predict the extent of spalling and fire resistance. The selected column is of 500 mm square cross-section and of 3 m length. The RC column was assumed to have a reinforcement comprising of 4-32 mm bars. The column was assumed to carry a load of 400 KN (40% of its load carrying capacity at room temperature) at the time of fire incident. The column was made of concrete of cube strength of 300 kg/cm<sup>2</sup> (cylinder strength of 25 MPa) and the reinforcement having a yield strength of 400 MPa. Also, the column is said to have bent ties (135° bent to the concrete core). The compartment fire shown in Fig. 13 was used as the fire scenario in the analysis. Since the permeability of concrete in the column is not known, fire resistance analysis was carried out by assuming three different orders of permeability ( $10^{-17}$ ,  $10^{-18}$ ,  $10^{-19}$ ).

Fig. 16 Loss of cross-section due to fire induced spalling
